## Buffton Lodge, Botcheston Road, Botcheston

Asset Type:	Building
Construction Date:	Late C19
Architect:	Unknown
Original Use:	Residential
Current Use:	Residential
Condition:	Good
Occupancy:	Occupied

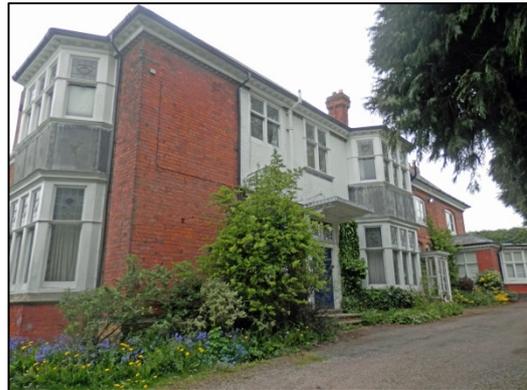
A good example of a large Victorian villa set within a large plot in a rural location. The earliest reference to the house by name is from 1862 but it has a largely late-19<sup>th</sup> century appearance. It is illustrative of the social, economic and cultural development of the Parish as higher status dwellings were constructed in large plots as finance became available following the success of local industry. The house was bought by Albert Pickard in 1901, he was a manufacturer of yarn and a local philanthropist who gave land for the Desford Recreation Ground and money towards building the village chapel. Architecturally the building was constructed with a range of styles and influences, although there is a predominant Domestic revival style. Interest remains with the red brick laid in an English bond, render infill, tall ridge and axial chimney stacks, Welsh slate roof covering, canted bay windows, leaded window lights, exposed rafter feet at the eaves, and polychromatic porch. Despite some minor alterations, extensions, and the subdivision of the house into three residential units the plan form and integrity of the original construction remains.

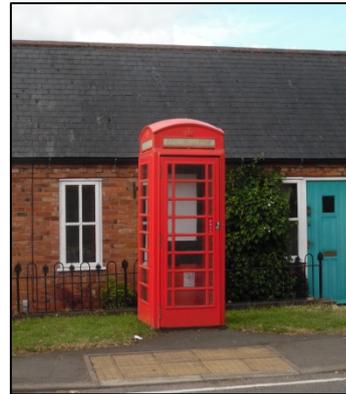
## K6 Telephone Box, Main Street, Botcheston

Asset Type:	Monument
Construction Date:	c. 1936 - 1953
Architect:	Sir Giles Gilbert Scott
Original Use:	Telephone Kiosk
Current Use:	Vacant?
Condition:	Good/Fair?
Occupancy:	Occupied?

One of only a few remaining type K6 telephone kiosks of this type within the borough, it provides a distinctive and iconic landmark within the street scene. The K6 kiosk was designed by the nationally renowned architect Sir Giles Gilbert Scott to commemorate the Silver Jubilee of the coronation of King George V in 1935. The kiosk was constructed in cast iron and finished in red to make them easy to spot. It is a square kiosk with a domed roof, unperforated crowns to top panels and margin glazing to the windows and door. This box has the Tudor Crown, which was in use between 1936 and 1953. **This particular kiosk is near to its original condition so retains a degree of integrity.** It has a clear aesthetic and functional relationship with the adjacent red post box located at the Manor Farm complex.

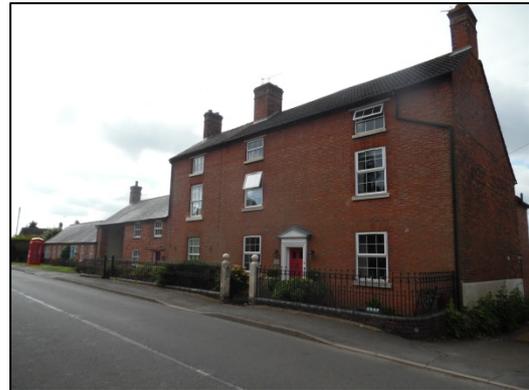
## Manor Farm complex, Main Street, Botcheston

Asset Type:	Building
Construction Date:	c. early C19
Architect:	Unknown
Original Use:	Agricultural/Residential
Current Use:	Predominantly Residential
Condition:	Good
Occupancy:	Occupied

A medium sized former farm complex comprising a large Georgian Manor House with attached rear wing to the east forming an L-shaped plan with courtyard to the rear and a single detached building. All buildings have now been converted to residential use and additional infill development has created a U-shaped plan. Small holdings remain on enclosed land to the south towards Rothley Brook. The Manor House likely dates from the early-19<sup>th</sup> century but the farm complex is likely to date from much earlier, possibly pre-enclosure given its location within the core of a linear settlement and proximity to the former open low lying meadows. The complex is illustrative of the social, economic and cultural development of Botcheston as a predominantly agricultural village. Architectural interest to the Manor House includes Flemish bond brickwork, tall gable and axial chimney stacks, a panelled door set within a decorative surround, and cambered window arches with rubbed bricks. Architectural interest to Manor Farm Cottage includes a dentil eaves course, canted blue brick cills and simple header treatments. Some original openings have been adapted for the agricultural building conversions. There is a Welsh slate covering on some sections of the frontage. Artistic interest includes ornate metal railings fronting the Manor House. Despite the more recent infill development the L-shaped plan form of the original complex remains discernible. The three storey height of the Manor House reflects its status and alongside the extent of the frontage of the attached range ensures the complex has a visual prominence and can be singled out as a landmark within the local street scene. It is part of a group of agricultural complexes developed within the settlement that have a clear historic association with each other. A red post box is integrated into the barn and has a clear aesthetic and functional relationship with the adjacent K6 telephone box.

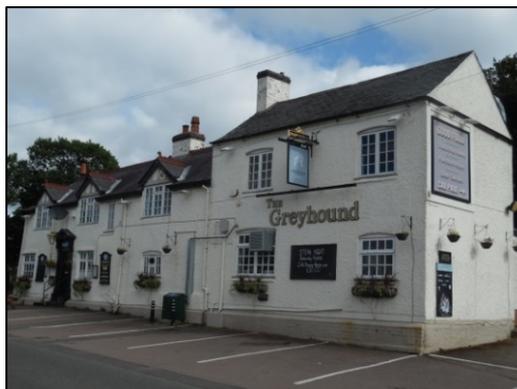
## The Greyhound Inn, Main Street, Botcheston

Asset Type:	Building
Construction Date:	c. early C19
Architect:	Unknown
Original Use:	Residential
Current Use:	Public house
Condition:	Good
Occupancy:	Occupied

A good example of a village public house. The building was originally likely to have been a number of cottages to house agricultural workers. It became a public house in 1856 with subsequent alterations during the late-19<sup>th</sup> century and more recently. It is illustrative of the social, economic and cultural development of Botcheston providing a typical function of a small village. Architectural interest includes a decorative door surround, terracotta ridge tiles, gable and ridge chimney stacks, chimney pots and finials and slate tiles. Artistic interest includes pub lettering and hanging sign to communicate the use of the building. It provides a critical communal function for the village and is a source of identity and social interaction. It is registered as an Asset of Community Value. The building has a visual prominence at the back edge of the road and can be singled out as a landmark within the local street scene.

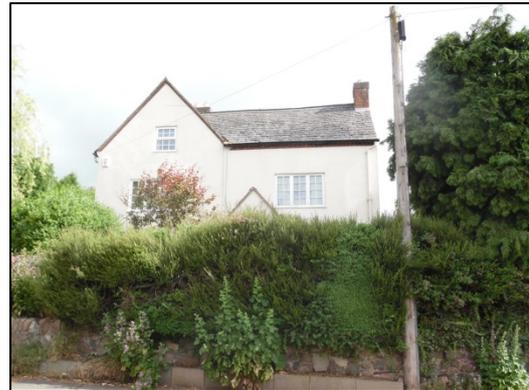
## Underbank Farm, Main Street, Botcheston

Asset Type:	Building
Construction Date:	c. early C19
Architect:	Unknown
Original Use:	Agricultural/Residential
Current Use:	Agricultural/Residential
Condition:	Good
Occupancy:	Occupied

A medium sized farm complex comprising an L-shaped farmhouse with attached rear wing to the north and a detached building set around a central courtyard. The current farmhouse likely dates from the early-19<sup>th</sup> century but the farm complex is likely to date from much earlier, possibly pre-enclosure given its location within the core of a linear settlement. It is illustrative of the social, economic and cultural development of Botcheston as a predominantly agricultural village. Architectural interest includes Swithland and Welsh slate roof coverings, gable and ridge chimney stacks, segmental arches and a dog tooth eaves course. The historic farmstead plan set around a loose courtyard remains discernible. Due to the height of the farmhouse gable end the building has a visual prominence and can be singled out as a landmark within the local street scene. It is part of a group of agricultural complexes that developed within the settlement which have a clear historic association with each other.

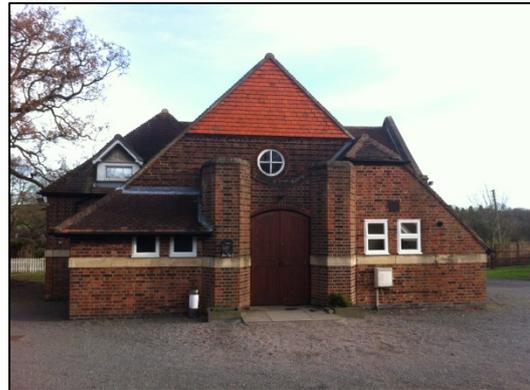
## Village Hall, Main Street, Botcheston

Asset Type:	Building
Construction Date:	1903
Architect:	Unknown
Original Use:	School
Current Use:	Village Hall
Condition:	Good
Occupancy:	Occupied

A good example of a former village school, constructed in 1903 in a Queen Anne style. The building has been used as a village hall since the 1970s. It is illustrative of the social, economic and cultural development of Botcheston providing a typical function of a small village. It includes a small stone memorial panel as an eloquent witness to the tragic impact of world events on the local community, and the sacrifice it made in the conflicts of the 20<sup>th</sup> century. Architectural interest includes English bond brickwork, stone bands with chamfered cills, prominent gables including a Dutch gable, circular window heads with basket weave brickwork, cambered arches, a catslide roof, hung tiles and hexagonal brick columns. It provides a critical communal function for the village and is a source of identity and social interaction. Despite some alterations including modern windows the integrity of the original construction remains. The building is sat within a large plot including a number of mature trees.

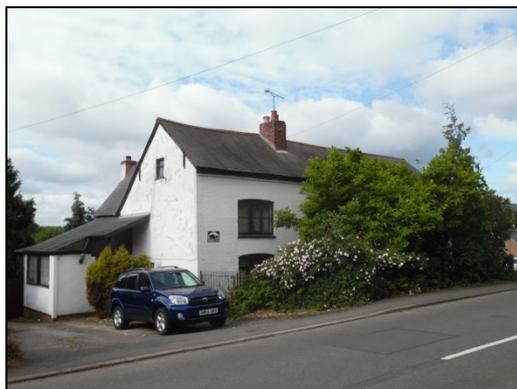
## Wayside Farm, Main Street, Botcheston

Asset Type:	Building
Construction Date:	c. late C18
Architect:	Unknown
Original Use:	Agricultural/Residential
Current Use:	Agricultural/Residential
Condition:	Good
Occupancy:	Occupied

A small farm complex comprising a linear farmhouse with small holdings on enclosed land to the south towards Rothley Brook. The height of the rear eaves and windows to the front indicate the current farmhouse dates from the 18<sup>th</sup> century with 19<sup>th</sup> century alterations including raising the height of the roof and re-roofing with Welsh slates. The stone base is rare and indicates that a building has been on the site since a much earlier date, likely pre-enclosure given its location within the core of a linear settlement and proximity to the former open low lying meadows. It is illustrative of the social, economic and cultural development of Botcheston as a predominantly agricultural village. Architectural interest includes slate roof coverings, axial chimney stacks, segmental window, arches, canted blue brick cills and a dog tooth eaves course. Due to the width of the frontage the building has a visual prominence and can be singled out as a landmark within the local street scene. It is part of a group of agricultural complexes that developed within the settlement which have a clear historic association with each other.

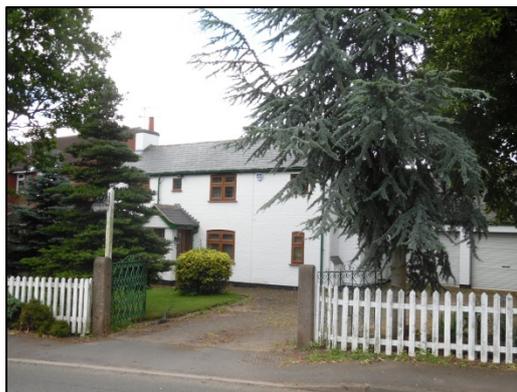
## White Cottage, Main Street, Botcheston

Asset Type:	Building
Construction Date:	c. early C19
Architect:	Unknown
Original Use:	Residential
Current Use:	Residential
Condition:	Good
Occupancy:	Occupied

A good example of simple early-19<sup>th</sup> century agricultural workers cottages, now adapted into a single dwelling with more recent alterations. The cottage is illustrative of the social and cultural development of Botcheston as a predominantly agricultural village with functional housing required to house workers. Architectural interest includes slate roof coverings, gable and ridge chimney stacks and segmental window arches.

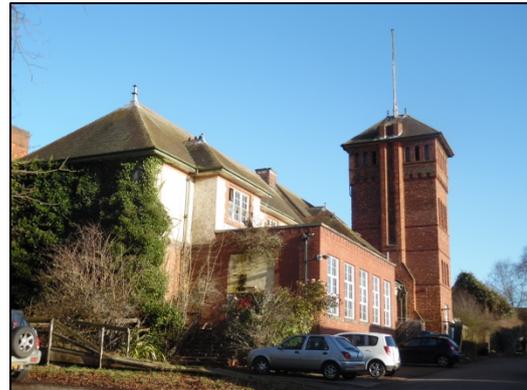
**Polebrook House, Markfield Lane (Kirby Grange), Botcheston**

Asset Type:	Building
Construction Date:	1881
Architect:	Leicester School Board
Original Use:	Industrial School
Current Use:	Care Home / Vacant
Condition:	Poor
Occupancy:	Partially Occupied

Leicester Industrial School built by the Leicester School Board and opened by A.J. Mundella MP in 1881. Industrial schools were established to care for children who had committed minor offences or were at the risk of crime. It was formerly certified to receive 200 boys but pupils came from all over the country to receive industrial training. The building is illustrative of a key period of late-19<sup>th</sup> century social reformation which has made an important contribution to the identity and character of Botcheston and the wider area. There is a significant contemporary and historic written record associated with the building which provides an important resource for understanding and learning about the area's history including residents of the school. Architectural interest includes a number of brick towers with one massive tower having decorative banding, piers and corbelling, the use of circular Norman arches for openings including a bold entrance porch set within decorative brickwork, a clay tile roof, large chimney stacks, hipped dormers, the use of finials, and clock set within a central gabled bay. It became an approved Boys School in 1933 and was known as Polebrook House from 1973 when it became a Community Home with Education but it closed in 1978. It then became a care home with a surrounding retirement home complex; the majority of the building now lies vacant. There are collective memories attached to the building through its former use and Old Boys meetings still take place. The scale of the building is imposing and the brick tower is local landmark that is an orientation point over a wide geographical area. The Industrial School is part of a group of buildings that have a clear historic, aesthetic and communal association.

More research and assessment is required regarding the recorded air raid shelter as this may be a potential candidate for the local heritage list

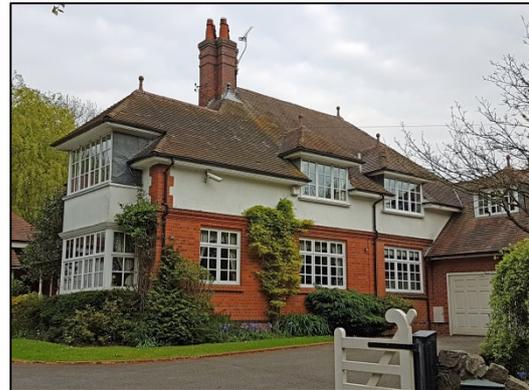
**Leicester Lodge, Markfield Lane (Kirby Grange), Botcheston**

Asset Type:	Building
Construction Date:	c. 1881
Architect:	Unknown
Original Use:	Lodge to Industrial School
Current Use:	Residential
Condition:	Good
Occupancy:	Occupied

<b>Selection Criteria:</b>
Historic value: illustrative interest / Aesthetic value: architectural interest / Integrity / Group value
<b>Reason for Designation:</b>
Former lodge to Leicester Industrial School now converted into residential use. The Leicester Industrial School was built by the Leicester School Board and opened in 1881 to care for children who had committed minor offences or were at the risk of crime. As with Markfield Lodge, Leicester Lodge is located adjacent to the school access drive and is a good illustrative example of a functional building once serving part of the wider school complex. Architecturally the lodge was constructed with Domestic revival influences, interest remains in the steeply pitched hipped roof and hipped half dormer windows, red brick laid in an English bond, decorative brick string course and window cills, render infill, rosemary clay tile roof covering, tall ridge chimney stack, terracotta ridge tiles and finials, and multi-paned casement windows. Despite some minor alterations and extensions the integrity of the original construction remains. Leicester Lodge is part of a group of buildings comprising the Leicester Industrial School that have a clear historic, aesthetic and communal association.

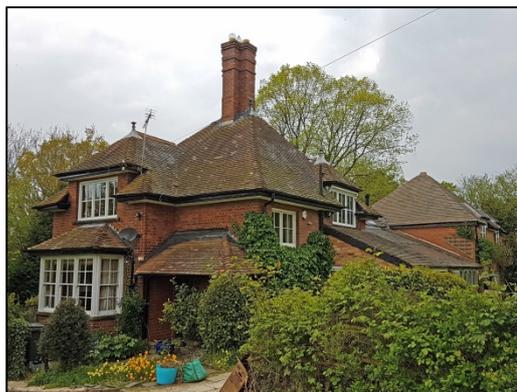
## Markfield Lodge, Markfield Lane (Kirby Grange), Botcheston

Asset Type:	Building
Construction Date:	c. 1881
Architect:	Unknown
Original Use:	Lodge to Industrial School
Current Use:	Residential
Condition:	Good
Occupancy:	Occupied

Former lodge to Leicester Industrial School now converted into residential use. The Leicester Industrial School was built by the Leicester School Board and opened in 1881 to care for children who had committed minor offences or were at the risk of crime. As with Leicester Lodge, Markfield Lodge is located adjacent to the school access drive and is a good illustrative example of a functional building once serving part of the wider school complex. Architecturally the lodge was constructed with Domestic revival influences, interest remains in the steeply pitched hipped roof and hipped half dormer windows, red brick laid in an English bond, rosemary clay tile roof covering, tall ridge chimney stack, leaded finials, terracotta ridge tiles, and multi-paned sash and casement windows. Despite some minor alterations and extensions the integrity of the original construction remains. Markfield Lodge is part of a group of buildings comprising the Leicester Industrial School that have a clear historic, aesthetic and communal association.

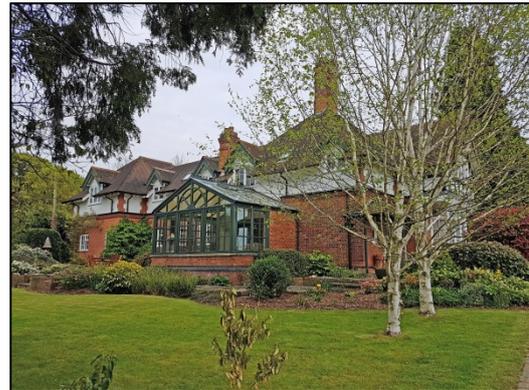
**Meadow Rise, Markfield Lane (Kirby Grange), Botcheston**

Asset Type:	Building
Construction Date:	1893
Architect:	Unknown
Original Use:	School Headmasters House
Current Use:	Residential
Condition:	Good
Occupancy:	Occupied

<b>Selection Criteria:</b>
Historic value: illustrative interest / Aesthetic value: architectural interest / Integrity / Group value
<b>Reason for Designation:</b>
Former house for the Headmaster of the Leicester Industrial School. The Leicester Industrial School was built by the Leicester School Board and opened in 1881 to care for children who had committed minor offences or were at the risk of crime. As with Lodge houses, the house is located adjacent to the school access drive and is a good illustrative example of a functional building once serving part of the wider school complex. Architecturally the lodge was constructed with Domestic revival influences, interest remains in the steeply pitched hipped roof, projecting gables and half dormer windows, red brick laid in an English bond, rosemary clay tile roof covering, render infill, mock timber framing, tall ridge chimney stack, leaded finials, terracotta ridge tiles, and multi-paned sash and casement windows. Despite some minor alterations and considerably sized extensions the integrity of the original construction remains. Meadow Rise is part of a group of buildings comprising the Leicester Industrial School that have a clear historic, aesthetic and communal association.

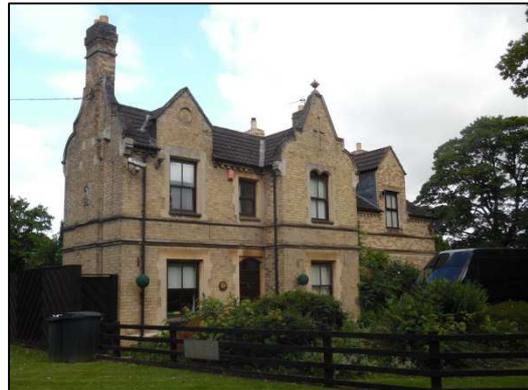
## Desford Hall Lodges, Leicester Lane, Desford

Asset Type:	Building
Construction Date:	c. 1875
Architect:	Unknown
Original Use:	Hall lodges
Current Use:	Residential
Condition:	Good
Occupancy:	Occupied

Two former lodges to Desford Hall now converted into residential use. The grade II listed Hall was constructed as a small country house in c.1875 (then known as Forest House, reverting to being known as Desford Hall by 1900) and was converted to offices c.1980. The two lodges are located at the southern corners of the Hall grounds and are good illustrative examples of a functional building serving a small estate. Architecturally the lodges were constructed with Queen Anne influences, interest remains in their steeply pitched roofs with Dutch gables, white brick laid in a Flemish bond with segmental arches, sections of herringbone, circles and cross brickwork in the gables, a dentil eaves course, stone windows surrounds, copings, finials and string courses, and tall gable, ridge and axial chimney stacks. Despite some alterations including modern windows and concrete tile roofs, and some extensions to each lodge, the integrity of the original construction remains. The lodge located to the south-west of the Hall grounds is located at the driveway to the Hall from Leicester Lane and has a visual prominence ensuring it can be singled out as a landmark within the local street scene. The lodges have a clear historic relationship with the grade II listed Hall and are the result of a deliberate design.

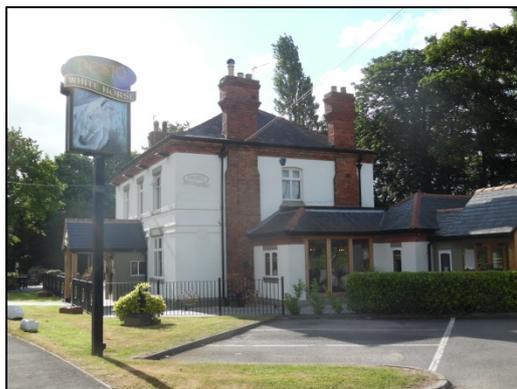
## Pesto (former White Horse PH), Leicester Lane, Desford

Asset Type:	Building
Construction Date:	c. late C19
Architect:	Unknown
Original Use:	Public House
Current Use:	Commercial
Condition:	Good
Occupancy:	Occupied

A good example of a former rural public house, now in use as a restaurant. It has a largely late-19<sup>th</sup> century appearance but the earliest reference of a public house on the site is from 1846 in White's Directory when John Gutteridge, a local farmer, was the licensee. It is illustrative of the social, economic and cultural development of Desford parish providing a typical function within an outlying and predominantly agricultural landscape. Architecturally the building was constructed to a Domestic style typical of a reformed public house of the late 19<sup>th</sup> century. Interest remains in the tall and dominant red brick chimney stacks, Welsh slate roof covering, terracotta ridge tiles, corbelling to the eaves, and canted brick cills. The building has a visual prominence at the back edge of the road and can be singled out as a landmark within the local street scene. Despite closing as a public house in 2015 the building remains in use as a source of identity and social interaction and provides a communal function for the parish.

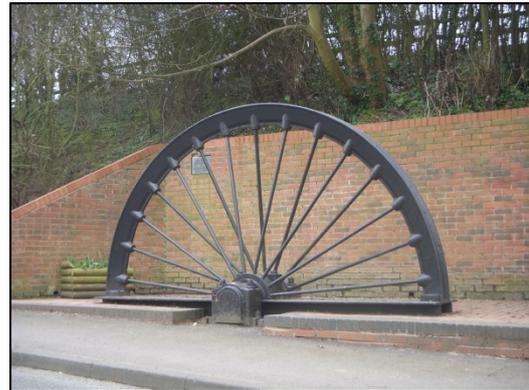
## Mine wheel, Lindridge Lane, Desford

Asset Type:	Site
Construction Date:	Unknown
Architect:	Unknown
Original Use:	Winding wheel at Desford Colliery
Current Use:	Ornamental
Condition:	Good
Occupancy:	Unoccupied

A former winding wheel the nearby Desford Colliery which was sunk in 1900 and closed in 1984. The wheel is illustrative of a local industry which shaped the social, economic and cultural development of the area through the 20<sup>th</sup> century. It provides a sense of identity and a physical reminder of past interactions between the area and the industry which contributes to the collective memory of the place. The wheel is one of the only remaining physical structures relating to the colliery and is highly recognisable and visible landmark within the street scene.

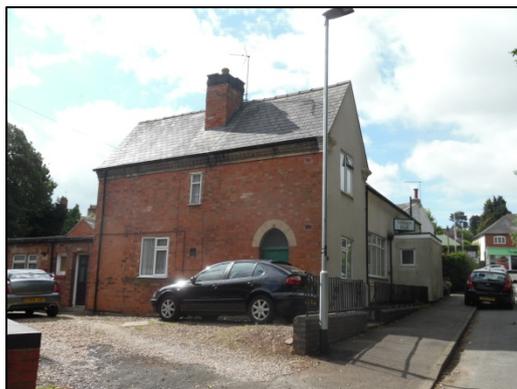
## Village Hall and No.12, Lindridge Lane, Desford

Asset Type:	Building
Construction Date:	Mid C19
Architect:	Unknown
Original Use:	Wesleyan Methodist Chapel
Current Use:	Residential and Village Hall
Condition:	Good
Occupancy:	Occupied

A former Wesleyan Methodist Chapel, now in use as a dwelling and the village hall. Records indicate the Methodist Chapel was established in the village by 1849. For a period during the mid-20<sup>th</sup> century the building was used as the Miners Institute serving the workers of the nearby Desford Colliery until being part converted into a separate dwelling and village hall by the end of the 20<sup>th</sup> century. It is illustrative of the social, economic and cultural development of Desford providing a range of functions typical of an expanding village, firstly non-conformist religion, secondly a social use for a local industry, and most recently a critical communal function as the village hall. The building was constructed in a Gothic revival style and despite alterations and additions some architectural interest remains including Flemish bond brickwork, an axial chimney stack, a pointed yellow brick arch over the door to no.12, decorative corbelling to the eaves and verges, and lancet windows to the village hall. The building has been a source of identity and social interest for nearly 200 years. The building has a visual prominence at the back edge of the road and can be singled out as a landmark within the local street scene.

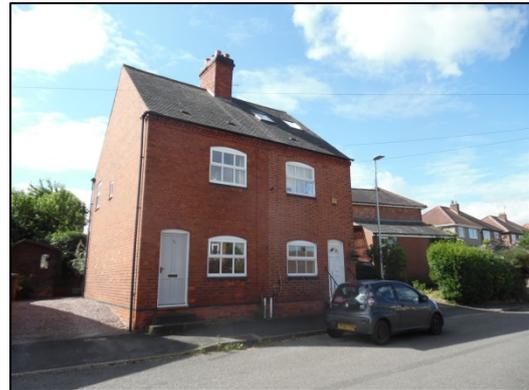
## No's 55 & 57 Newbold Road, Desford

Asset Type:	Building
Construction Date:	Mid C19
Architect:	Unknown
Original Use:	Residential
Current Use:	Residential
Condition:	Good
Occupancy:	Occupied

A good example of a pair of mid-Victorian workers cottages. They are illustrative of the social, economic and cultural development of Desford as it expanded in size during this period and functional housing was required to house workers. Architectural interest includes Flemish bond brickwork, a Welsh slate roof covering, shared ridge chimney stack, segmental brick arches, canted blue brick cills, dog tooth eaves course, and a panelled door to no.55. The cottages have a visual prominence at the back edge of the pavement and can be singled out as a landmark within the local street scene. Through the piecemeal development of the area the group of properties numbered 55, 57, 59 & 61 Newbold Road provide a good example of the predominant historical styles of residential properties from the mid-19<sup>th</sup> century to the mid-20<sup>th</sup> century.

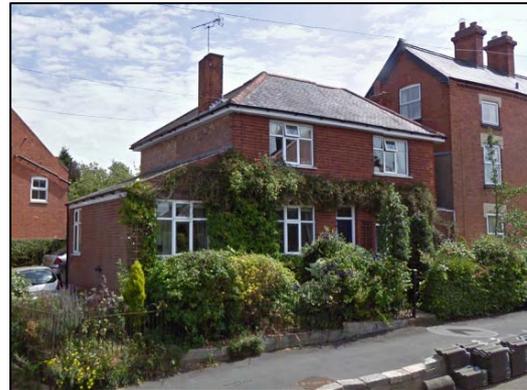
## No.59 Newbold Road, Desford

Asset Type:	Building
Construction Date:	c. 1930s
Architect:	Unknown
Original Use:	Residential
Current Use:	Residential
Condition:	Good
Occupancy:	Occupied

A good example of single dwelling constructed to a typical Council house style. It is illustrative of the social, economic and cultural development of Desford as it expanded in size during the post-WWI period and functional housing was required. It was a Victory Garden during WWII so was the only house in the village allowed to keep the iron railings along the front and side boundary, the railings survive as something that was once quite common and provide some artistic interest. Due to the openness of the site frontage the building does have a visual prominence and can be singled out as a landmark within the local street scene. Through the piecemeal development of the area the group of properties numbered 55, 57, 59 & 61 Newbold Road provide a good example of the predominant historical styles of residential properties from the mid-19<sup>th</sup> century to the mid-20<sup>th</sup> century.

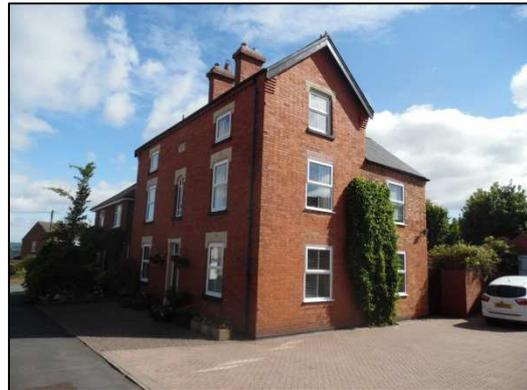
## No.61 Newbold Road, Desford

Asset Type:	Building
Construction Date:	1886
Architect:	Unknown
Original Use:	Residential
Current Use:	Residential
Condition:	Good
Occupancy:	Occupied

A good example of late-Victorian villa. The building is illustrative of the social, economic and cultural development of Desford as it expanded in size during this period and higher status dwellings were constructed in large plots on the rural-urban fringe. Architectural interest includes Flemish bond brickwork, large ridge chimney stacks, decorative stone/concrete lintels, dog tooth course and corbelling to the eaves, verge bargeboards and terracotta ridge tiles. There is name/date stone "Moorwood House 1886". Despite some modern alterations the building retains a sense of completeness. Due to its scale the building has a visual prominence and can be singled out as a landmark within the local street scene. Through the piecemeal development of the area the group of properties numbered 55, 57, 59 & 61 Newbold Road provide a good example of the predominant historical styles of residential properties from the mid-19<sup>th</sup> century to the mid-20<sup>th</sup> century. For a period the house was used by St. Dunstan's home for the blind so the building may have some community value.

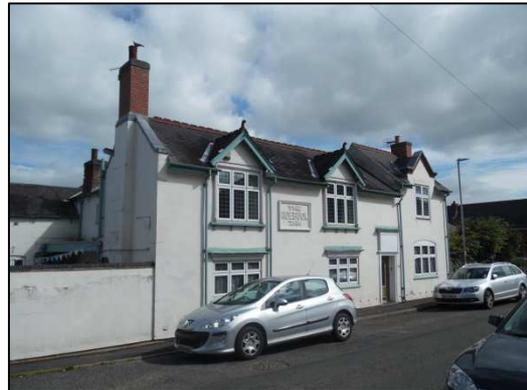
## Former Roebuck Inn, Newbold Road, Desford

Asset Type:	Building
Construction Date:	c. late C19
Architect:	Unknown
Original Use:	Public House
Current Use:	Residential
Condition:	Good
Occupancy:	Occupied

A good example of a former village public house, now converted into residential use. It has a largely late-19<sup>th</sup> century appearance but the earliest reference of a public house on the site is from 1825. The number of bays suggests the building could have originally formed a number of cottages before the change of use and subsequent late-19<sup>th</sup> century alterations. It is illustrative of the social, economic and cultural development of Desford providing a typical function of an expanding village. Architecturally the building was constructed with a range of styles and influences, interest remains in the Welsh slate roof covering, gabled half dormers with finials and bargeboards, terracotta ridge tiles, canted brick and decorative cills, projecting headers, decorative door surrounds, metal rainwater goods, and gable chimney stacks. Artistic interest includes the carved name panel and space for further signage above the entrance door which communicates the former use and history of the building. The building provided a communal function and despite its closure as a public house in 2010 it remains a source of identity that contributes to the collective memory of the village. Due to the width of the frontage the building has a visual prominence and can be singled out as a landmark within the local street scene.

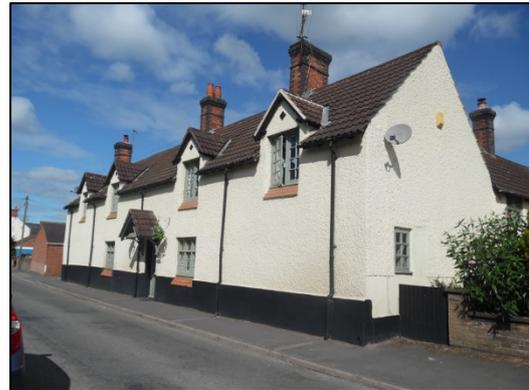
## Gables Farm, Newbold Road, Desford

Asset Type:	Building
Construction Date:	c. mid C19
Architect:	Unknown
Original Use:	Agricultural/Residential
Current Use:	Residential/Commercial
Condition:	Good
Occupancy:	Occupied

A small farm complex comprising a linear farm house with attached wing forming a U-plan courtyard. Former stables have been converted into residential use. Further detached buildings to the north and west comprising separate dwellings and a livery and equestrian business located on a small holding on enclosed land to the north. The current farm house likely dates from the mid-19<sup>th</sup> century but the farm complex is likely to date from much earlier, possibly pre-enclosure given its location within the core of a linear settlement. There is some timber framing evident in the western gable end. It is illustrative of the social, economic and cultural development of Desford as a predominantly agricultural village. Architectural interest includes overhanging eaves, large ridge chimney stacks, diamonds set within gabled half dormers, canted brick cills. Some original openings have been adapted for the stable conversion and its clay tile roof covering remains. The historic farmstead plan set around a loose courtyard remains discernible. Due to the width of the farm house frontage the building has a visual prominence and can be singled out as a landmark within the local street scene.

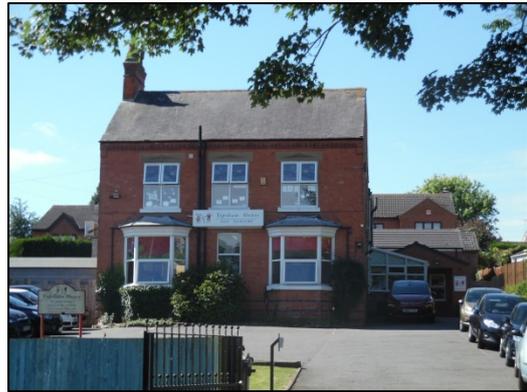
## Debdale (now Topsham Nursery), Peckleton Lane, Desford

Asset Type:	Building
Construction Date:	Early C20
Architect:	Unknown
Original Use:	Residential
Current Use:	Nursery
Condition:	Good
Occupancy:	Occupied

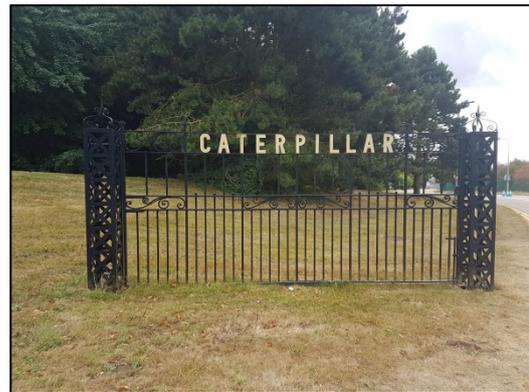
Asset Type:	Site
Construction Date:	c. 1952
Architect:	Caterpillar Tractor Co
Original Use:	Gates (access)
Current Use:	Gates (ornamental)
Condition:	Good
Occupancy:	N/A

The entrance gates are one of the only remaining structures associated with the founding of the Caterpillar Tractor Company in 1952, with this being the first venture of the company outside the United States of America and founded on the former Desford airfield. The gates are illustrative of an industrial company that has and continues to make an important contribution to the social and economic development of the area and further afield. The gates are likely constructed of wrought iron and have ornate elements within the design giving them an artistic interest which communicates the name and status of the company. The gates are perceived a source of identity and social interaction due to the amount of people that have and continue to pass through them as employees of the company. The gates have been restored to their original condition and are a landmark feature at the current entrance to the company premises.

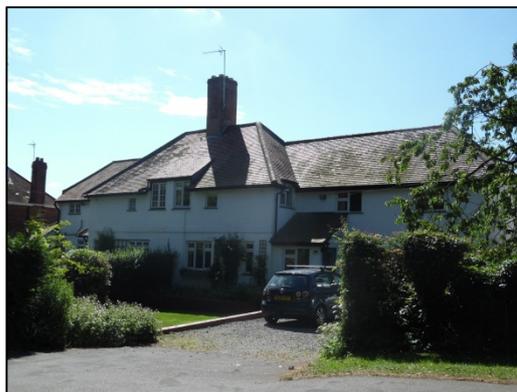
Asset Type:	Building
Construction Date:	1920s
Architect:	Unknown
Original Use:	Residential
Current Use:	Residential
Condition:	Good
Occupancy:	Occupied

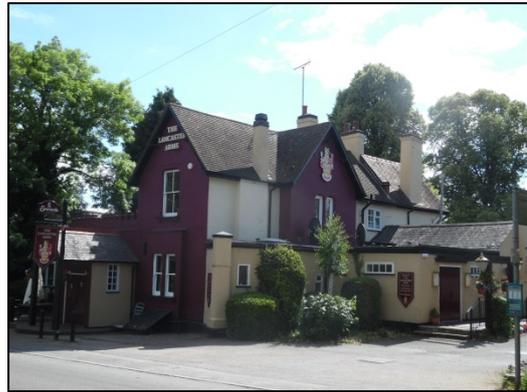
Asset Type:	Building
Construction Date:	c. 1860s
Architect:	Joseph Dymock
Original Use:	Residential/Public House
Current Use:	Public House
Condition:	Good
Occupancy:	Occupied

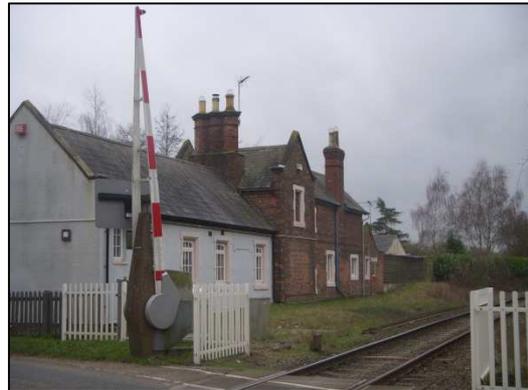
Asset Type:	Building
Construction Date:	c. 1848
Architect:	Leicester to Swannington Railway Company
Original Use:	Railway Station
Current Use:	Residential
Condition:	Good
Occupancy:	Occupied

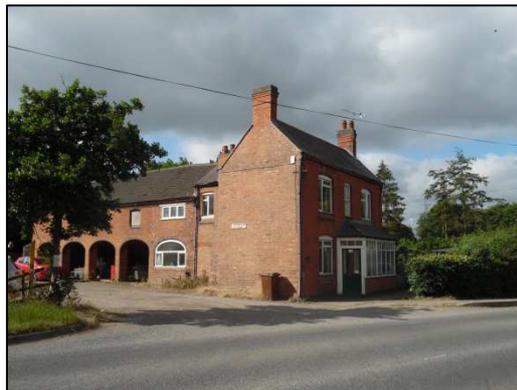
Asset Type:	Building
Construction Date:	c. late C18
Architect:	Unknown
Original Use:	Agricultural/Residential
Current Use:	Agricultural/Residential
Condition:	Good
Occupancy:	Occupied

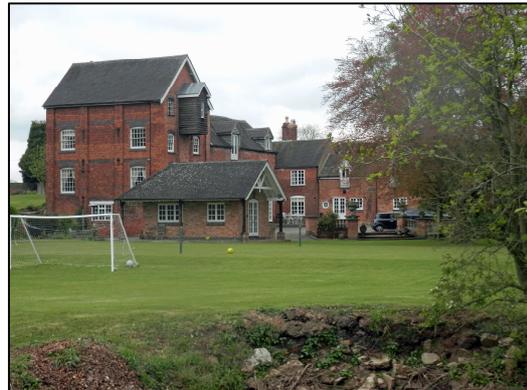
Asset Type:	Building
Construction Date:	c. late C18
Architect:	Unknown
Original Use:	Watermill
Current Use:	Residential
Condition:	Good
Occupancy:	Occupied

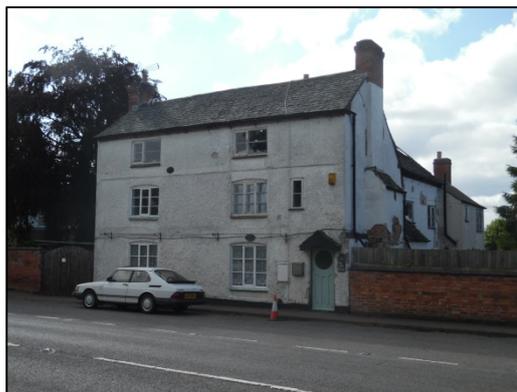
Asset Type:	Building
Construction Date:	c. early C19
Architect:	Unknown
Original Use:	Agricultural/Residential
Current Use:	Residential
Condition:	Fair
Occupancy:	Occupied

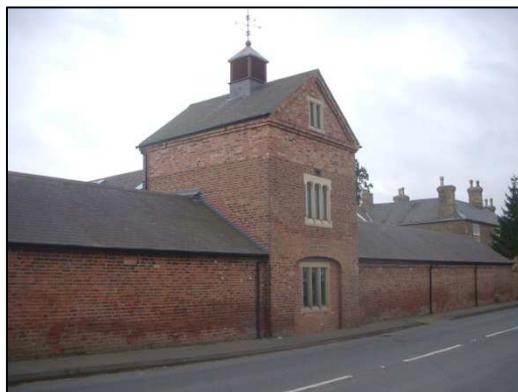
Asset Type:	Building
Construction Date:	c. late C18
Architect:	Unknown
Original Use:	Agricultural/Residential
Current Use:	Agricultural/Commercial
Condition:	Good
Occupancy:	Occupied

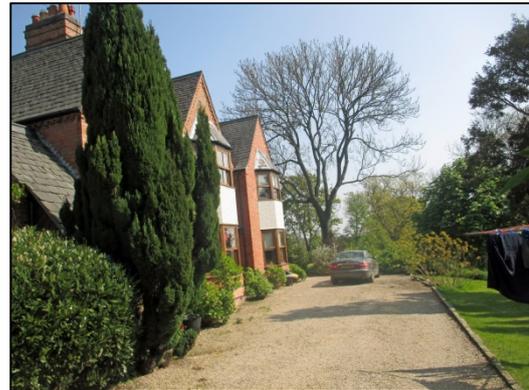
Asset Type:	Building
Construction Date:	c. mid C19
Architect:	Unknown
Original Use:	Agricultural/Residential
Current Use:	Agricultural/Residential
Condition:	Fair
Occupancy:	Occupied

A medium sized farm complex comprising an L-shaped farmhouse with a detached U-shaped complex of associated farm buildings including ranges of cottages, loose boxes/stable and barns. Due to its isolated location away from a settlement the farm complex was likely to have been established following the period of Enclosure, with the farm buildings likely dating from the mid-19<sup>th</sup> century whilst the farmhouse has a late-19<sup>th</sup> century appearance. It is illustrative of the social, economic and cultural development of agricultural practices within the Parish following Enclosure. The complex was known as County Asylum Farm up until the end of the 19<sup>th</sup> century as residents of the Leicester Asylum were sent for employment and resided in the cottages. By 1904 the complex had reverted to the name Woodlands Farm. Architectural interest to the original frontage range of the farmhouse includes steeply pitched projected gables with local but rare Swithland slates, a tall axial chimney stack, canted bay windows and dentil eaves courses. The cottages and attached agricultural buildings retain architectural interest through their functional openings and construction materials. Despite the erection of a number of surrounding 20<sup>th</sup> century agricultural buildings the historic U-shaped plan form of the detached ranges remains.
